U.S. Department
of Transportation
**Federal Aviation
Administration**

Aviation Maintenance Alerts

**ALERT NO. 257
DECEMBER 1999**

**Improve Reliability-
Interchange Service
Experience**

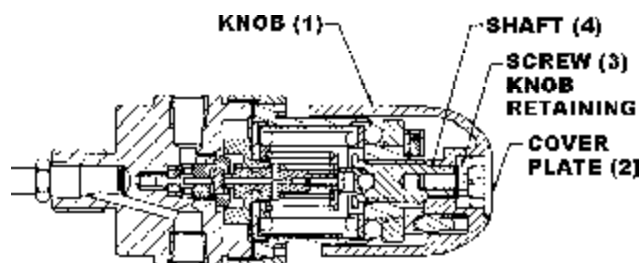
Figure 1

Items (1), (2), and (3) are not to be tampered with or removed. If the knob (1) is removed and reassembled allowing two complete turns of the regulator shaft (4), bottle high pressure will be allowed to enter the low pressure side/system. Knob (1) is always assembled with the regulator shaft (4) backed completely out and the knob (1) is kept from rotation when tightening the knob retaining screw (3). Note: With the knob (1) correctly installed, rotation will never exceed 1.13 turns by design. It is recommended that the knob (1) remain on the regulator at all times except for regulator overhaul or knob replacement. Knob (1) is to remain on the regulator during shipping and after any regulator removal from the cylinder; for example, hydrostatic testing of the cylinder.

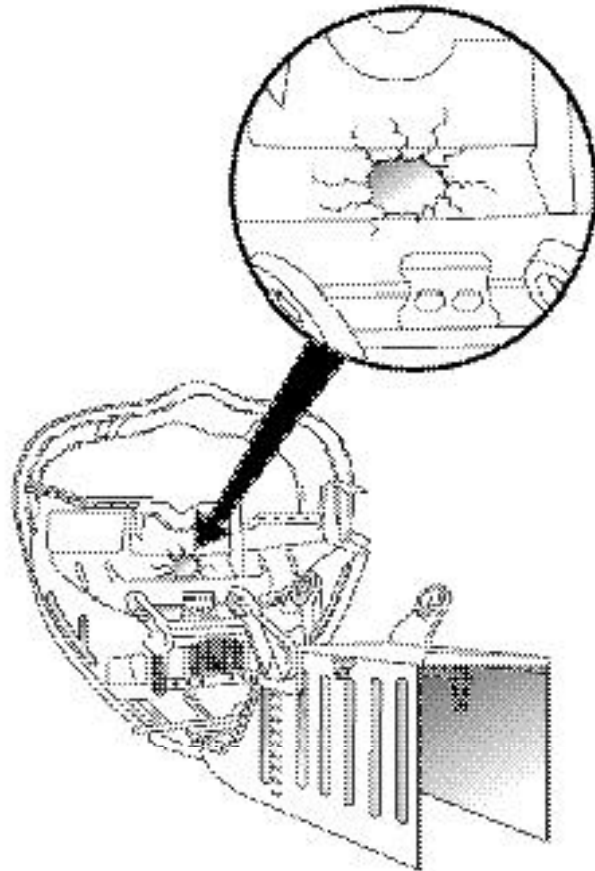
During an annual inspection, the technician discovered the nose cowling cracked and broken.

The technician found the nose cowling pan (P/N 002-410014-3) severely cracked and a section measuring approximately 2 inches by 4 inches missing. The damage was located below the engine crankshaft flange opening and above the air filter. (Refer to the following illustration.) The cracks radiated from the missing cowling section in various directions and lengths. The aft oil cooler baffle was also cracked.

The submitter attributed this damage to operational vibrations.

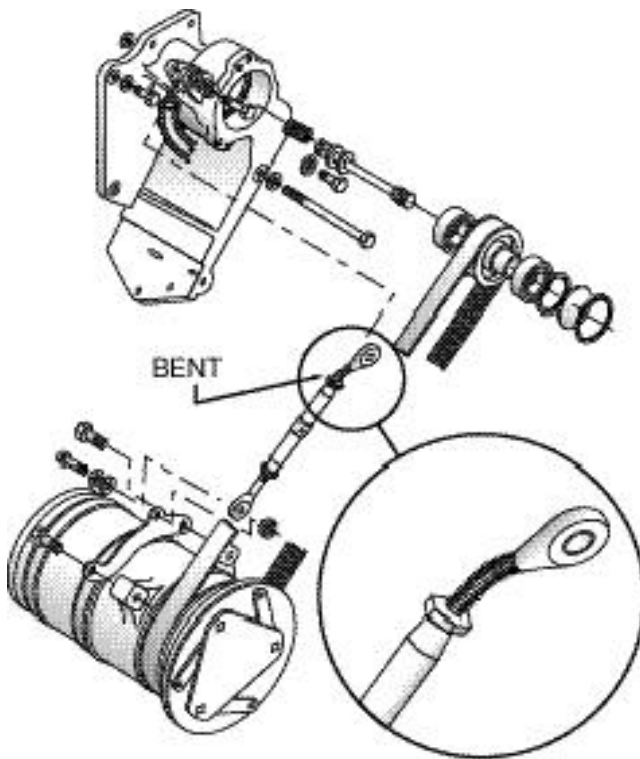
During a post-flight inspection, the maintenance technician discovered a bent rod-end used on the air-conditioning system.

The rod-end (P/N 115-555026-15) connects the compressor drive pulley assembly to the compressor, and is used to adjust the compressor belt tension. The rod-end was bent approximately 10 degrees allowing the drive belt tension to decrease. (Refer to the following illustration.) The submitter stated he has found this defect on other like aircraft, and speculated the rod-end may not be strong enough for this application.

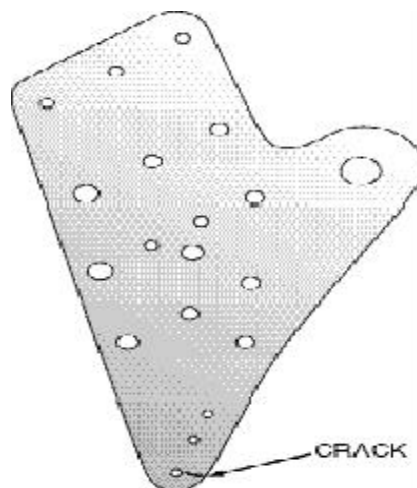
During an annual inspection, the technician discovered a cracked lower lift strut fitting (P/N 0713610-9).

This finding prompted the inspection of other like aircraft, where technicians found three additional cracked fittings. The cracks were all in the same location, with the crack radiating out of the lowest rivet hole. (Refer to the following illustration.) The cracks are located under the floor boards near the seam of the belly skin and are hard to see. Replacing the fitting requires extensive sheet metal work.

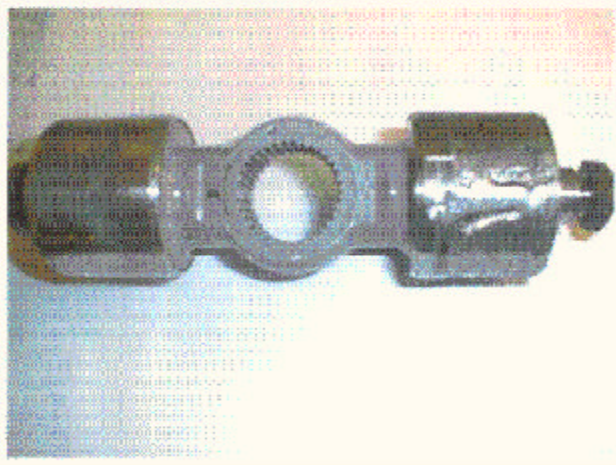
A maintenance technician inspected the assembly and confirmed that the tail rotor was defective. When the tail rotor assembly (P/N 109-8131-02-125) was removed, two score marks were found on the trunnion (P/N 109-0131-05-115). One of the scored areas was approximately .75-inch long and .25-inch wide. The second area was .6-inch long and .5-inch wide. The tail rotor hub bushing had a "mirror" image of the scored marks on the trunnion. (Refer to the following illustration.)

Technicians removed the tail rotor assembly 40 hours prior to this discovery, and all of the components were serviceable at that time. Authorities could not determine the cause of this damage.
